# Pilot Study of Inspection of Hydraulic and Slope Stabilizing Structures by Using UAV and High-Resolution Thermal Imaging

Speaker: **Yi-Min Huang**, Ph.D.

Assistant Professor, Dept. of Civil Engineering, FCU

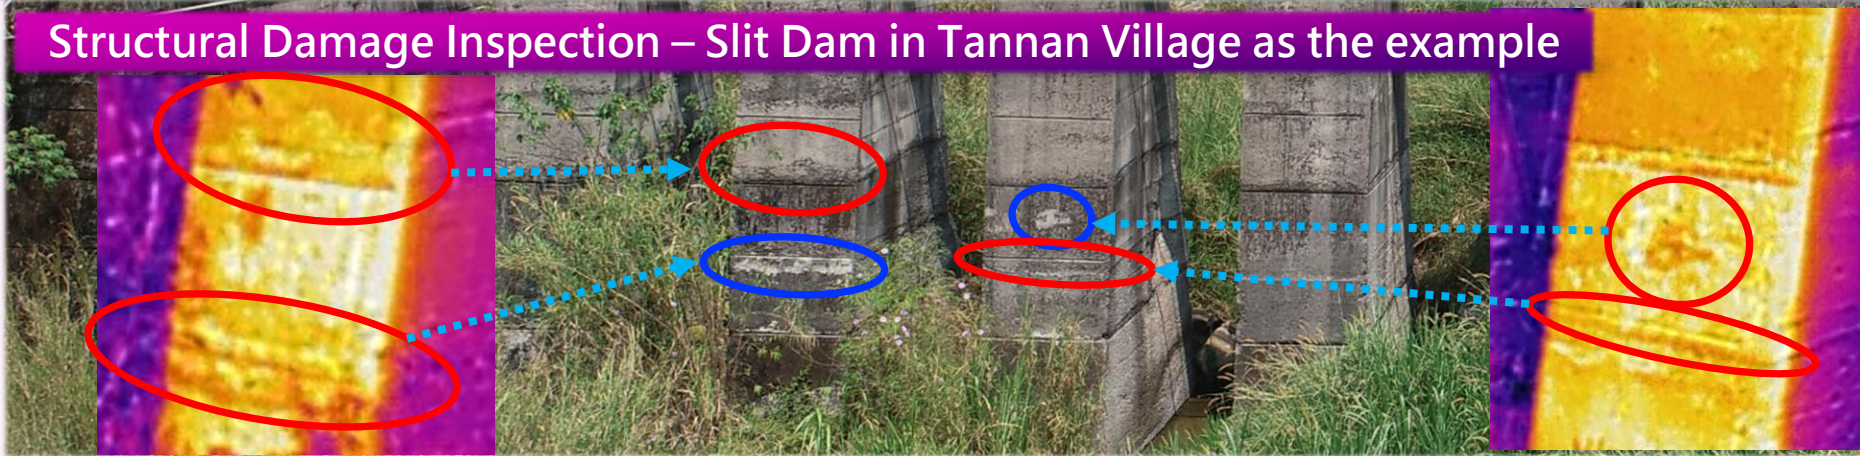
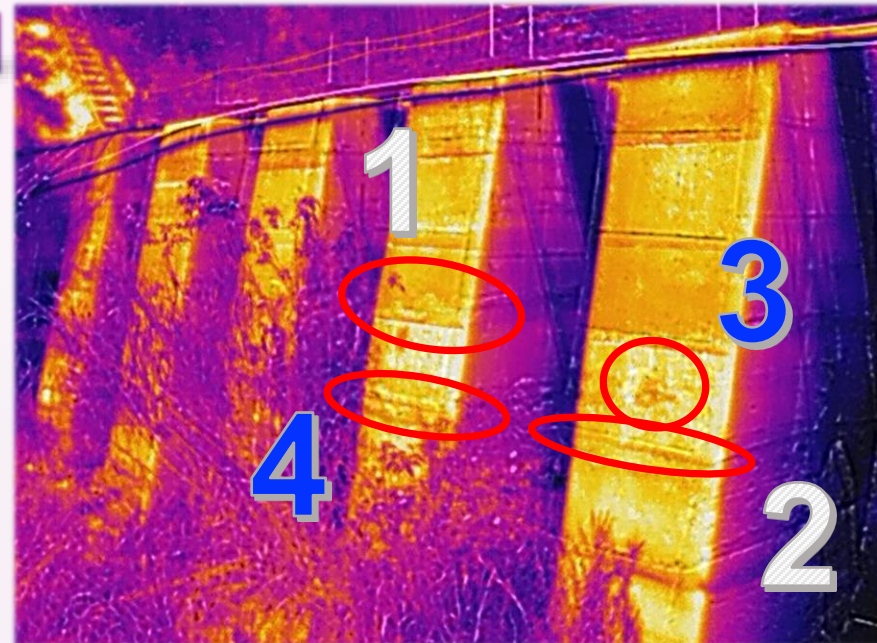
Structural Damage Inspection – Slit Dam in Tannan Village as the example

Comparison of RGB & Thermal Images

Irregular linear patterns in 1 & 2

➡ suspected cracks

Irregular shapes and linear pattern  
in 3 & 4

➡ possible defects of RC

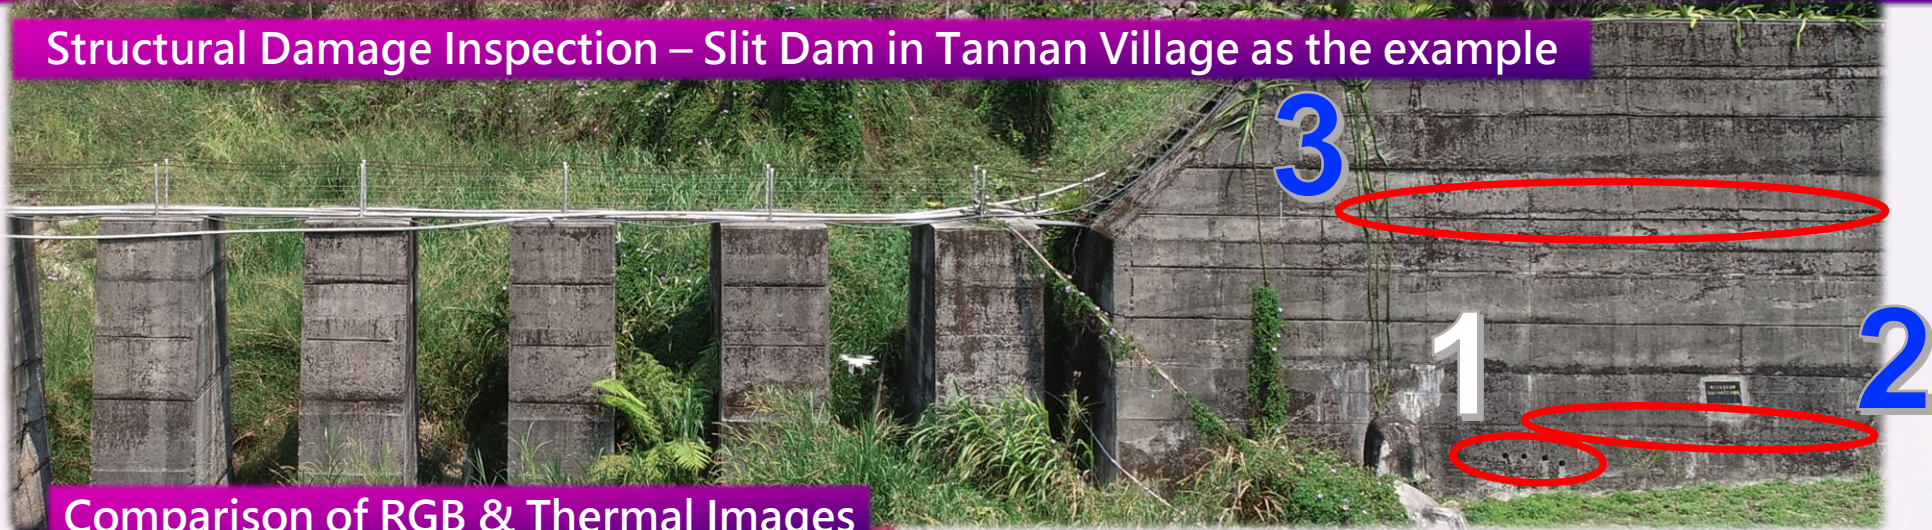
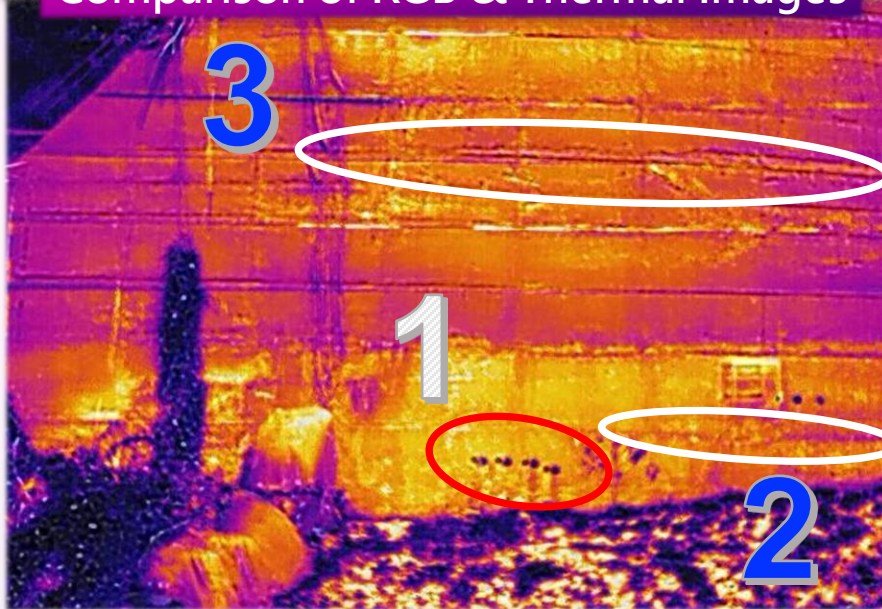
Structural Damage Inspection – Slit Dam in Tannan Village as the example

Comparison of RGB & Thermal Images

- Dark circular patterns in 1  
➡ **Confirmed** as coring holes (for testing)
- Irregular linear patterns in 2 & 3  
➡ **suspected** cracks
